Obrecheuil river quality assessment and improvement (Belgium)

A river quality assessment was achieved along its fourteen kilometers. This allowed to highlight hydromorphological issues or imbalances. Then suitable improvement projects were designed.

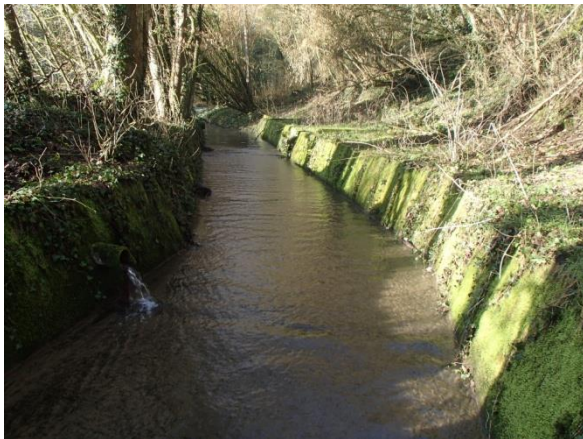
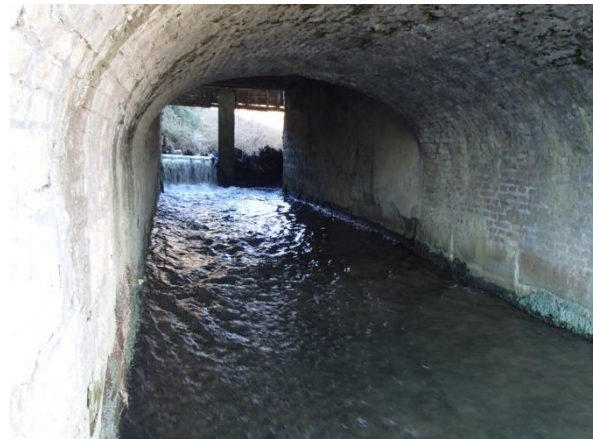
Some river sections were particularly damaged because of inappropriate land use in the floodplain, artificial banks or riverbed structures or works being obstacles to waterflow, fish and sediments.

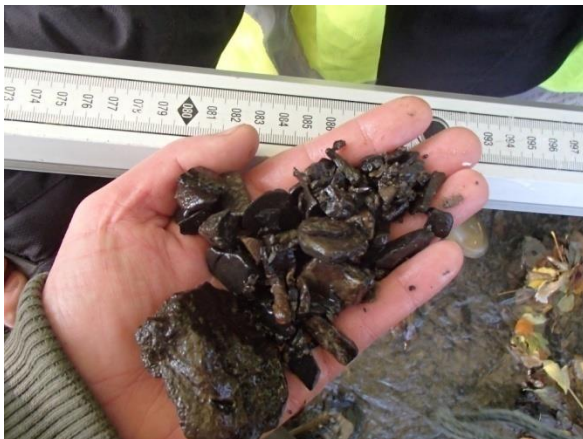
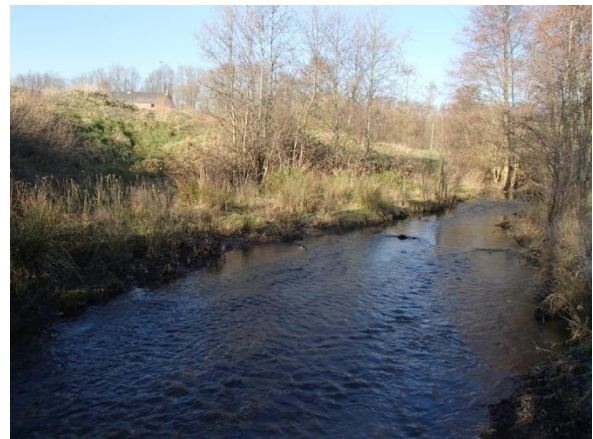
The quality assessment along the river course has fortunately also highlighted some quite natural sections which have to be preserved.
